**Prepared for:**

## POOL/SPA & EQUIPMENT

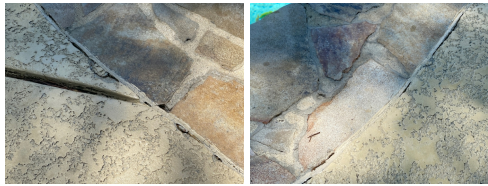
**COPING DEFECT(S)**

The mastic joint between the coping and the decking has no moisture sealant, or the sealant has become compromised, or the sealing is NOT correct per industry standards.

Sealant prevents rain water from getting below the decking and potentially compromising pool integrity.

Recommend sealant be replaced.

Recommend getting estimate(s) of this repair.

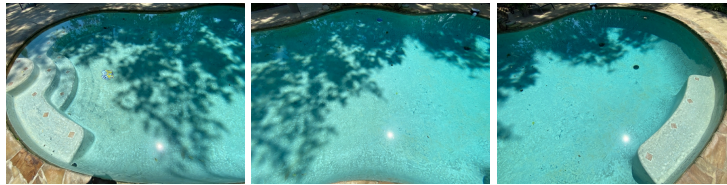
### CONDITION OF SURFACE

Surface appeared in usable condition at time of inspection. The life span of a pool surface is dependent on several factors most of which includes the maintenance and upkeep of the pool water chemistry.

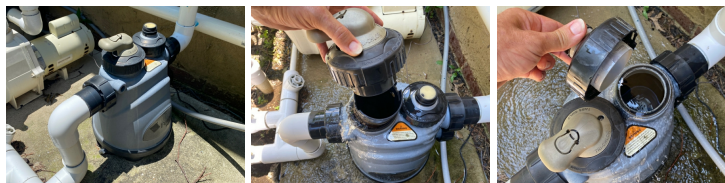
### FUSION CHLORINE FEEDER SYSTEM

Sanitizer system appeared to be operating within normal limits at time of inspection.

Manufacturer recommends algacide cartridge, in compartment adjacent to chlorine feeder, be replaced every 6 months.

Recommend installing a new mineral cartridge.

Recommend getting estimate(s) of this repair.
